**Flood Control Project Maintenance  
Levee Inspections**

**Maintenance Issue Types Only, Levee Inspection Report By Mile - Fall 2016**

**Reclamation District No. 0544 Upper Roberts Island**

Waterway	Bank	Unit Miles	Inspection Start/End	Inspector
Unit No. 01 San Joaquin River	Left	6.05	10/12/2016 11/02/2016	Richard Willoughby

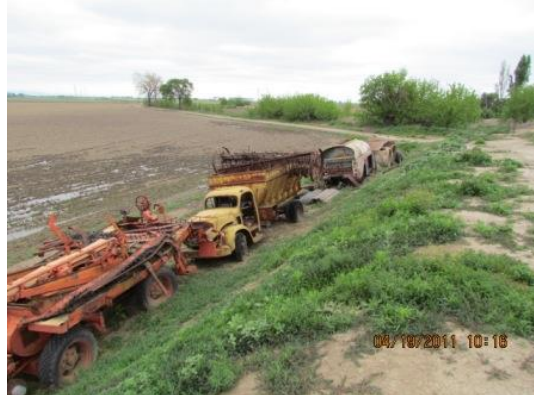
Photo 4 of 5 : FA\_2016\_RD0544\_108\_4\_20160929\_00007.jpg

LM Start	0.06	Rating **	M	Issue No.	4 (cont)	
LM End	0.19	Issue Type +	Ma	Location *	LS	
Category	Earthen Levee			GPS Latitude/Longitude		
				Start		End
Item	Encroachments			37.869606 °		37.868163 °
				-121.329571 °		-121.328132 °
DWR ID	DWR_RD0544_01_s_2012_4					
Comment Code						
EQ : Equipment						
Inspector Comment						
Farm equipment and supplies stored at landward toe.

Looking north at equipment along landside toe.

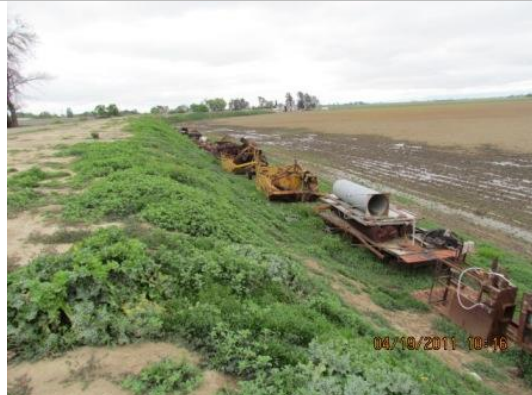
Photo 5 of 5 : FA\_2016\_RD0544\_108\_4\_20160929\_00008.jpg

Looking south at equipment along landside toe.

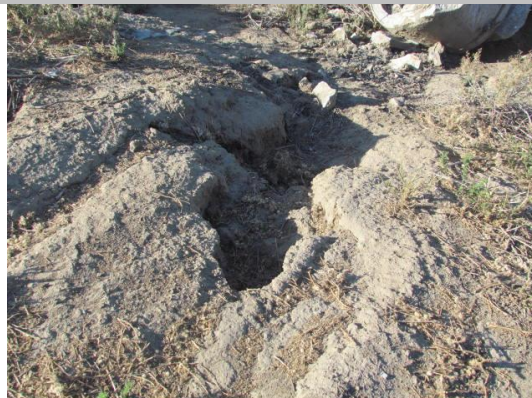
Photo 1 of 1 : FA\_2016\_RD0544\_108\_118\_20160929\_00072.jpg

LM Start	0.06	Rating **	U	Issue No.	118
LM End	0.06	Issue Type +	Ma	Location *	LS
Category	Earthen Levee			GPS Latitude/Longitude	
				Start	End
Item	Erosion / Bank Caving			37.869570 °	37.869570 °
				-121.329556 °	-121.329556 °
DWR ID	DWR_RD0544_01_f_2015_118				
Comment Code					
E1 : Note and monitor erosion site.					
Inspector Comment					
Finger erosion noted on landward slope.

Looking west at landside erosion for shoulder to middle of levee slope.

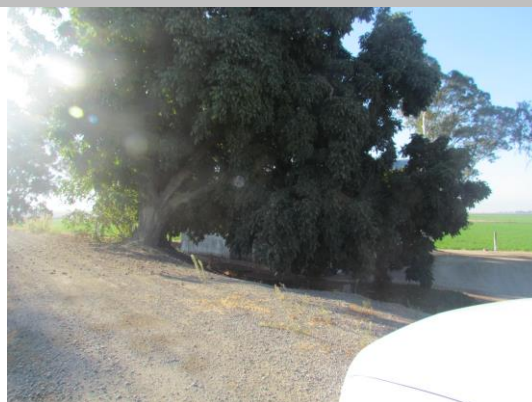
Photo 1 of 1 : FA\_2016\_RD0544\_108\_2\_20161107\_00131.jpg

Looking southwest at untrimmed tree on landward slope.

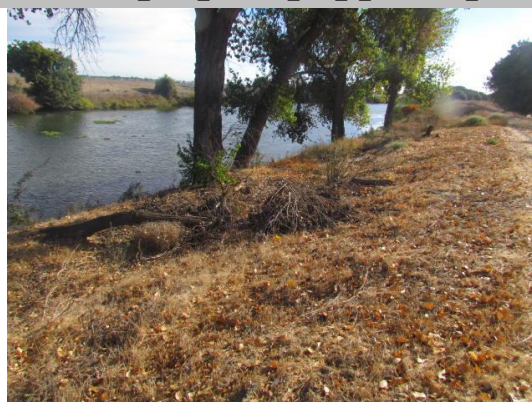
Photo 1 of 1 : FA\_2016\_RD0544\_108\_6\_20160929\_00010.jpg

LM Start	0.45	Rating **	M	Issue No.	6	
LM End	0.45	Issue Type +	Ma	Location *	WS	
Category	Earthen Levee			GPS Latitude/Longitude		
				Start		End
Item	Encroachments			37.864713 °		37.864713 °
				-121.326708 °		-121.326708 °
DWR ID	DWR_RD0544_01_f_2013_6					
Comment Code						
PR : Prunings						
Inspector Comment						
Broken tree limbs on waterward slope and berm.

Looking southeast at tree branch on waterward slope.

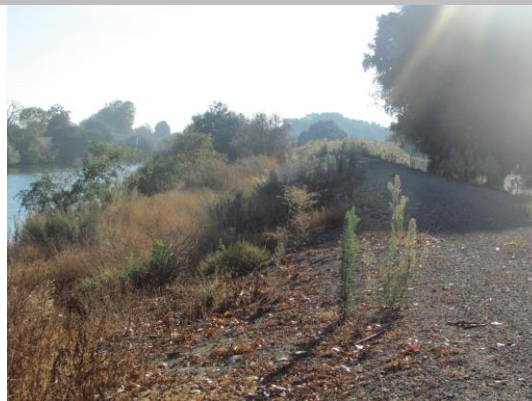
Photo 1 of 1 : FA\_2016\_RD0544\_108\_3\_20161107\_00132.jpg

Looking south at dense veg on waterward slope.

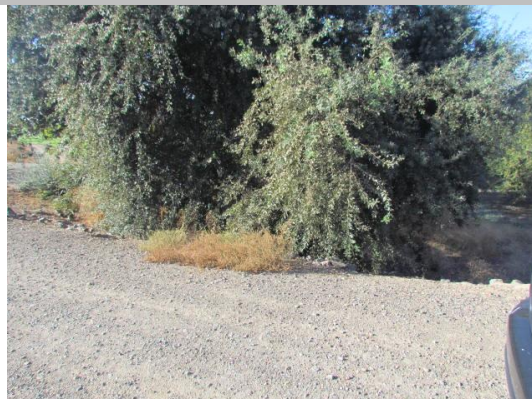
Photo 1 of 1 : FA\_2016\_RD0544\_108\_93\_20160929\_00057.jpg

Looking west at untrimmed trees on landward slope and toe fall 2015.

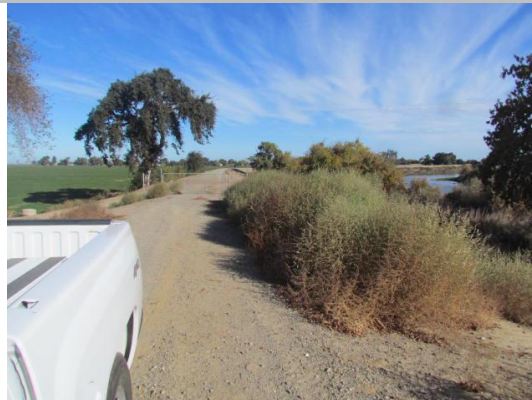
Photo 1 of 1 : FA\_2016\_RD0544\_108\_94\_20160929\_00058.jpg

Looking north at vegetation on waterward shoulder and slope.

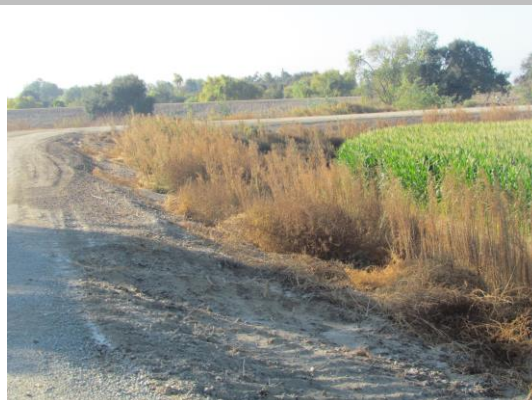
Photo 1 of 1 : FA\_2016\_RD0544\_108\_42\_20161107\_00136.jpg

Looking at dense veg. on landward slope and toe.

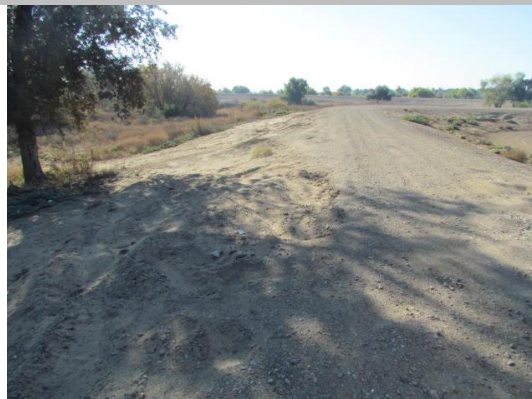
Photo 1 of 3 : FA\_2016\_RD0544\_108\_119\_20160929\_00073.jpg

LM Start	1.50	Rating **	U	Issue No.	119
LM End	1.51	Issue Type +	Ma	Location *	WS
Category	Earthen Levee			GPS Latitude/Longitude	
				Start	End
Item	Slope Stability			37.854844 °	37.854564 °
				-121.321090 °	-121.321031 °
DWR ID	DWR_RD0544_01_f_2015_119				
Comment Code					
S3 : Repair the levee slope damaged by vehicle traffic and prevent access where possible.					
Inspector Comment					
Damaged levee slope due to fishermen using slope as a ramp.

Looking southeast at damaged waterward slope fall 2015.

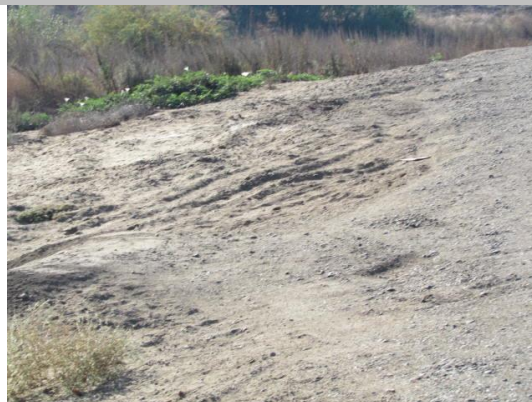
Photo 2 of 3 : FA\_2016\_RD0544\_108\_119\_20160929\_00074.jpg

Looking east at damaged waterward slope fall 2015.

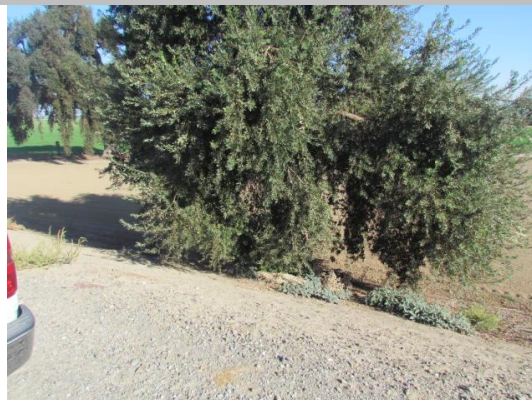
Photo 1 of 1 : FA\_2016\_RD0544\_108\_96\_20160929\_00059.jpg

Looking at untrimmed tree on landward slope and toe.

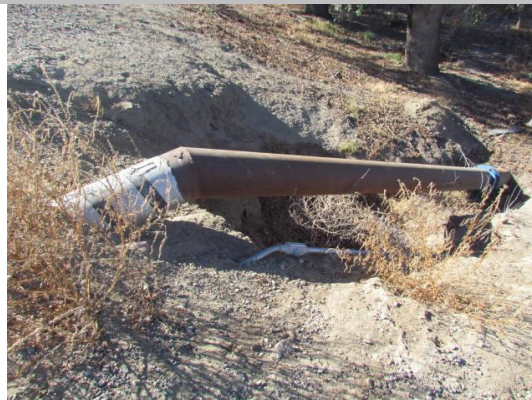
Photo 1 of 3 : FA\_2016\_RD0544\_108\_23\_20160929\_00017.jpg

LM Start	2.26	Rating **	U	Issue No.	23
LM End	2.26	Issue Type +	Ma	Location *	LS
Category	Earthen Levee			GPS Latitude/Longitude	
				Start	End
Item	Erosion / Bank Caving			37.848155 °	37.848155 °
				-121.324897 °	-121.324897 °
DWR ID	DWR_RD0544_01_s_2012_23				
Comment Code					
E2 : Schedule repair of erosion site prior to the next inspection.					
Inspector Comment					
Caving/erosion around irrigation pipe on landside slope.

Looking south at erosion around irrigation pipe on landside slope. (Fall 2014)

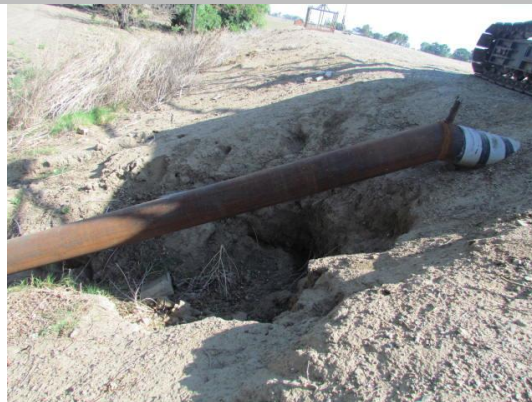
Photo 2 of 3 : FA\_2016\_RD0544\_108\_23\_20160929\_00018.jpg

Looking north at erosion under irrigation pipe on landside slope.

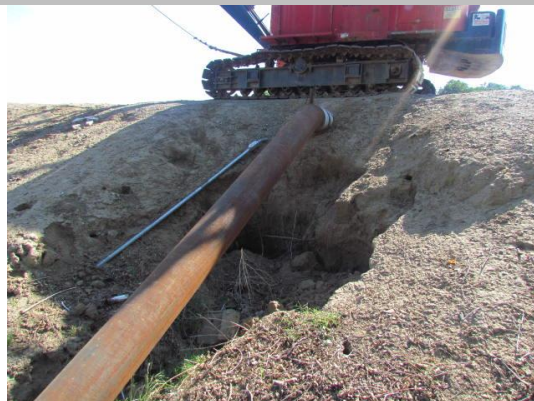
Photo 3 of 3 : FA\_2016\_RD0544\_108\_23\_20160929\_00019.jpg

LM Start	2.26	Rating **	U	Issue No.	23 (cont)	
LM End	2.26	Issue Type +	Ma	Location *	LS	
Category	Earthen Levee			GPS Latitude/Longitude		
				Start		End
Item	Erosion / Bank Caving			37.848155 °		37.848155 °
				-121.324897 °		-121.324897 °
DWR ID	DWR_RD0544_01_s_2012_23					
Comment Code						
E2 : Schedule repair of erosion site prior to the next inspection.						
Inspector Comment						
Caving/erosion around irrigation pipe on landside slope.

Looking east at erosion under irrigation pipe on landside slope.

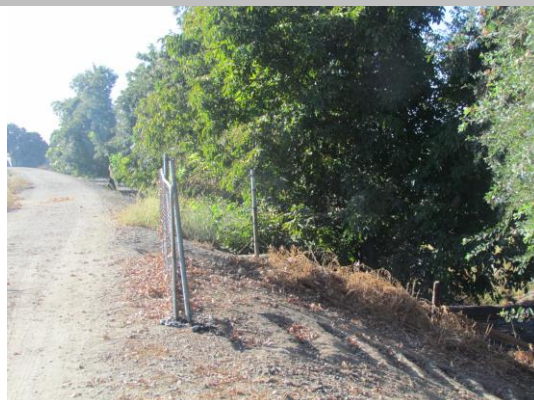
Photo 1 of 1 : FA\_2016\_RD0544\_108\_98\_20161107\_00139.jpg

Looking south at untrimmed trees on landward slope.

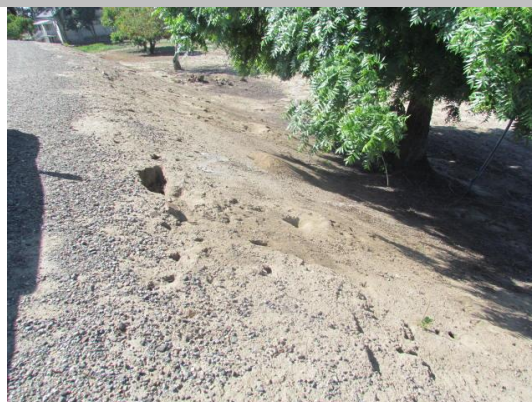
Photo 1 of 2 : FA\_2016\_RD0544\_108\_34\_20160929\_00025.jpg

Looking south at several rodent holes on landward shoulder and slope.

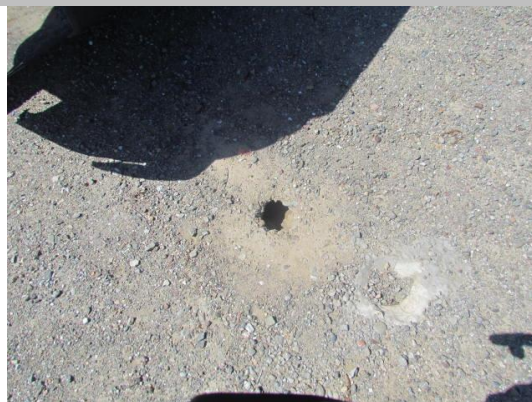
Photo 2 of 2 : FA\_2016\_RD0544\_108\_34\_20160929\_00026.jpg

Looking at rodent hole on levee crown.

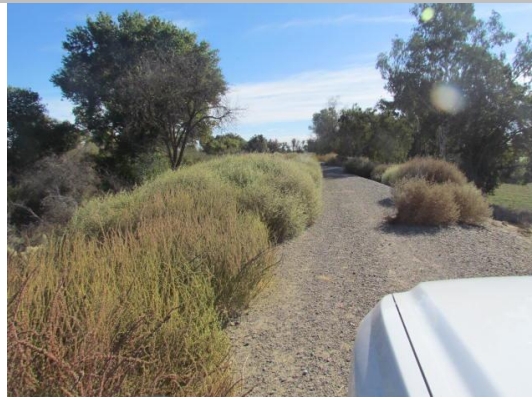
Photo 1 of 1 : FA\_2016\_RD0544\_108\_99\_20160929\_00060.jpg

Looking south at dense vegetation on waterward shoulder and slope.

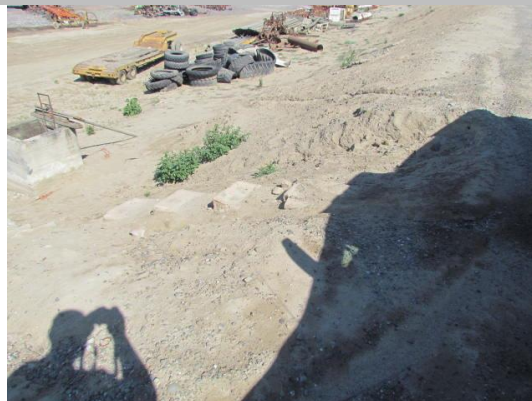
Photo 1 of 2 : FA\_2016\_RD0544\_108\_60\_20160929\_00041.jpg

LM Start	2.57	Rating **	M	Issue No.	60
LM End	2.57	Issue Type +	Ma	Location *	LS
Category	Earthen Levee			GPS Latitude/Longitude	
				Start	End
Item	Slope Stability			37.844337°	37.844337°
				-121.321853°	-121.321853°
DWR ID	DWR_RD0544_01_s_2012_60				
Comment Code					
S2 : Repair the levee slope damaged by foot traffic and prevent access where possible.					
Inspector Comment					
Finger erosion on landward slope.

Looking north at slope damage on landside slope.

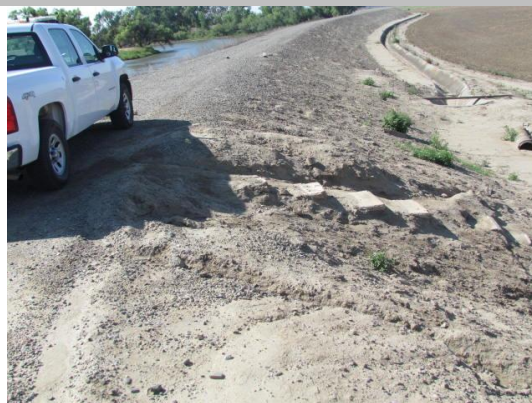
Photo 2 of 2 : FA\_2016\_RD0544\_108\_60\_20160929\_00042.jpg

Looking south at slope damage on landside slope.

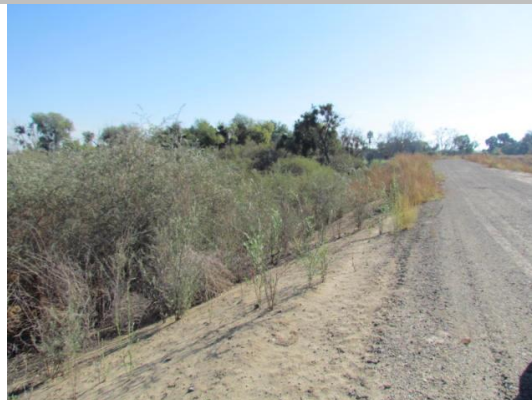
Photo 1 of 1 : FA\_2016\_RD0544\_108\_106\_20160929\_00064.jpg

Looking southeast at dense willows (veg) on waterward slope and toe fall 2015.

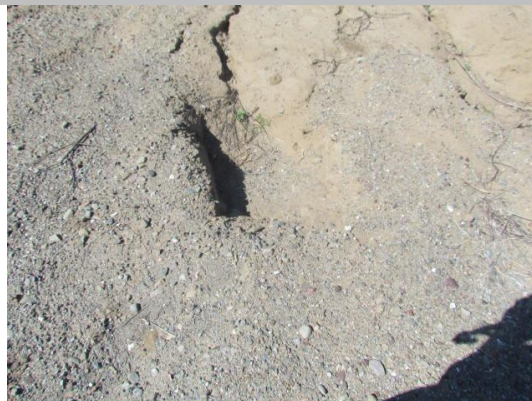
Photo 1 of 2 : FA\_2016\_RD0544\_108\_107\_20160929\_00065.jpg

Looking south at depression on landward slope.

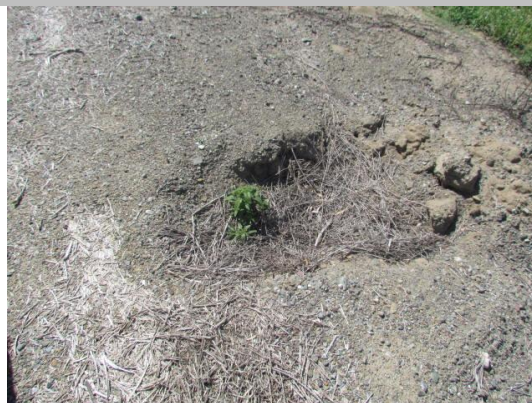
Photo 2 of 2 : FA\_2016\_RD0544\_108\_107\_20160929\_00066.jpg

Looking west at depression on landward shoulder.

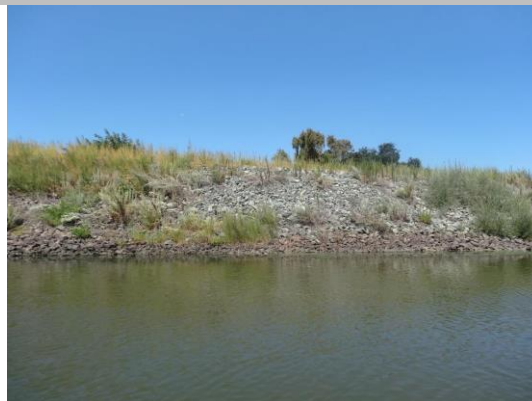
Photo 1 of 2 : SJR2016\_RD0544U01RM49.67\_1.jpg

07/25/2016: No significant change observed.  
 06/24/2015: No significant change observed.  
 06/19/2014: No significant change observed.  
 08/13/2013: Pump has been removed. A larger pocket erosion has been found at the erosion site.  
 08/07/2012: The erosion is immediately upstream of a river bend. Dense vegetation is visible at the erosion site. [2016 Site ID:RD0544U01RM49.67]

Front view of the erosion.

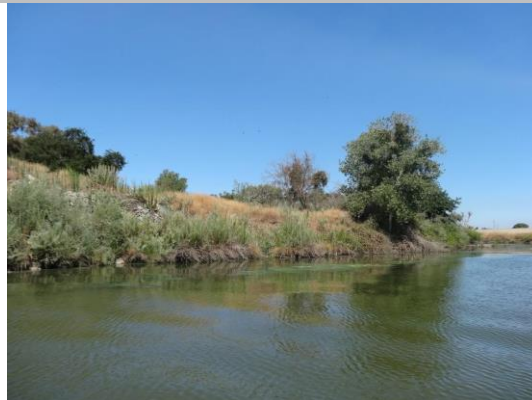
Photo 2 of 2 : SJR2016\_RD0544U01RM49.67\_3.jpg

Close view of the site.

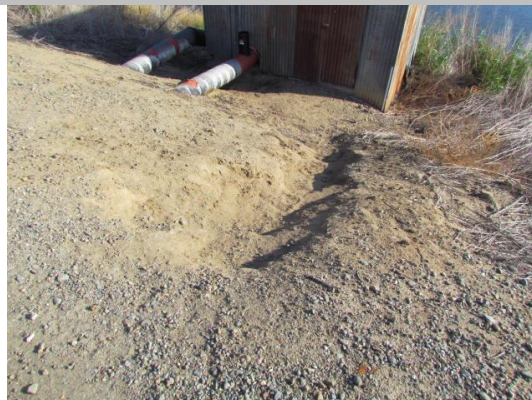
Photo 1 of 1 : FA\_2016\_RD0544\_108\_62\_20160929\_00043.jpg

LM Start	3.17	Rating **	M	Issue No.	62
LM End	3.17	Issue Type +	Ma	Location *	WS
Category	Earthen Levee			GPS Latitude/Longitude	
				Start	End
Item	Slope Stability			37.837530°	37.837530°
				-121.317510°	-121.317510°
DWR ID	DWR_RD0544_01_s_2012_62				
Comment Code					
S2 : Repair the levee slope damaged by foot traffic and prevent access where possible.					
Inspector Comment					
Slope damage due to foot traffic.

Looking east at slope damaged by foot traffic near pump house on waterside of levee.

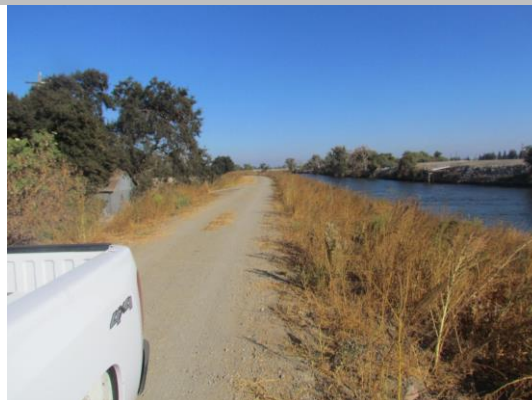
Photo 1 of 1 : FA\_2016\_RD0544\_108\_49\_20161107\_00140.jpg

Looking northeast at dense veg on waterward slope.

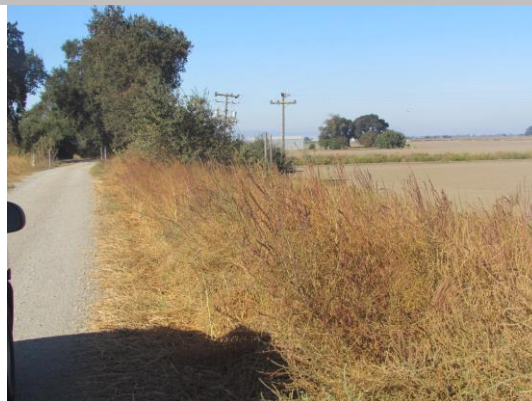
Photo 1 of 1 : FA\_2016\_RD0544\_108\_48\_20161107\_00141.jpg

Looking south at typical view of dense veg on landward slope.

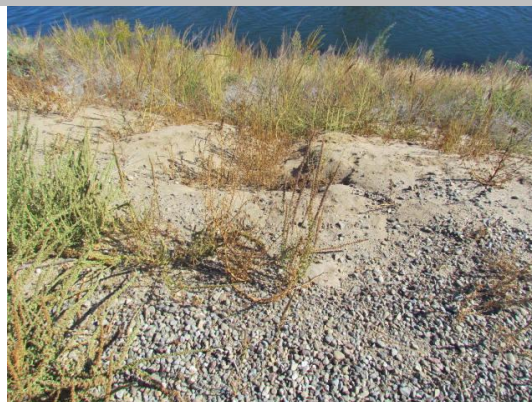
Photo 1 of 1 : FA\_2016\_RD0544\_108\_50\_20160929\_00039.jpg

LM Start	3.29	Rating **	M	Issue No.	50
LM End	3.29	Issue Type +	Ma	Location *	WS
Category	Earthen Levee			GPS Latitude/Longitude	
				Start	End
Item	Erosion / Bank Caving			37.835815 °	37.835815 °
				-121.316997 °	-121.316997 °
DWR ID	DWR_RD0544_01_s_2012_50				
Comment Code					
E1 : Note and monitor erosion site.					
Inspector Comment					
Erosion located on waterside shoulder. Erosion caused by rain runoff.

Looking east at erosion on waterward slope.

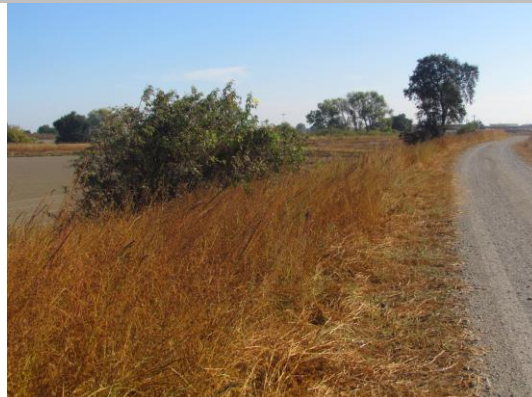
Photo 1 of 1 : FA\_2016\_RD0544\_108\_52\_20161107\_00143.jpg

Looking south at dense veg on landward slope.

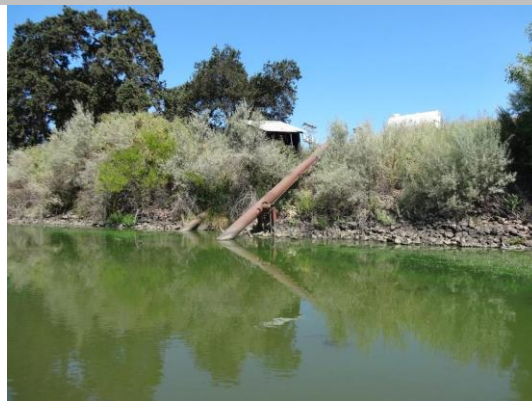
Photo 1 of 2 : SJR2016\_RD0544U01RM51.04\_1.jpg

LM Start	4.23	Rating **	M	Issue No.	84
LM End	4.24	Issue Type +	Ma	Location *	WS
Category	Supplemental			GPS Latitude/Longitude	
				Start	End
Item	DWR Erosion Survey			37.825248 °	37.825248 °
				-121.313856 °	-121.313856 °
DWR ID					
Comment Code					
Inspector Comment					
07/25/2016: No significant change observed.					
06/24/2015: No significant change observed.					
06/19/2014: No significant change observed.					
08/13/2013: The erosion has been caused by irrigation pipe. [2016 Site ID:RD0544U01RM51.04]

Front view of the site.

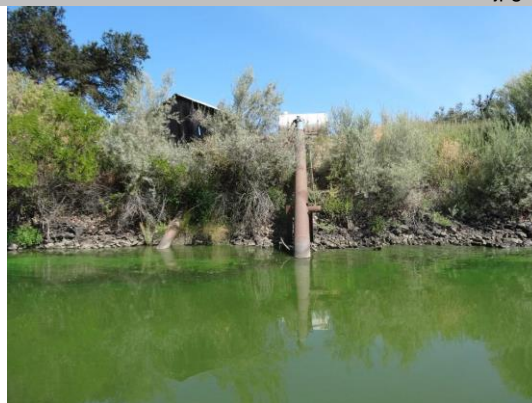
Photo 2 of 2 : SJR2016\_RD0544U01RM51.04\_3.jpg

Close view of the site.

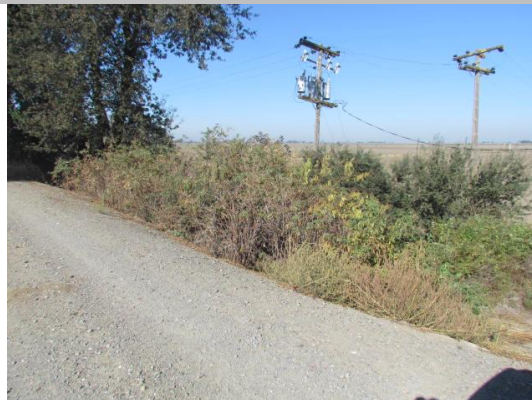
Photo 1 of 1 : FA\_2016\_RD0544\_108\_57\_20160929\_00040.jpg

Looking southwest at dense elderberries on landward slope fall 2015.

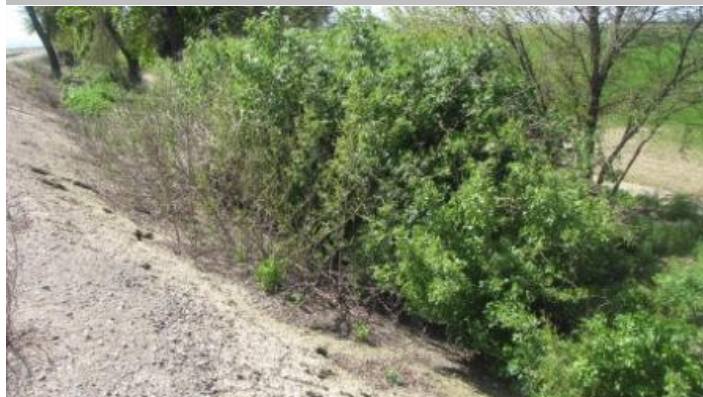
Photo 1 of 1 : FA\_2016\_RD0544\_108\_41\_20160929\_00033.jpg

Looking south at elderberries on landside slope and toe.

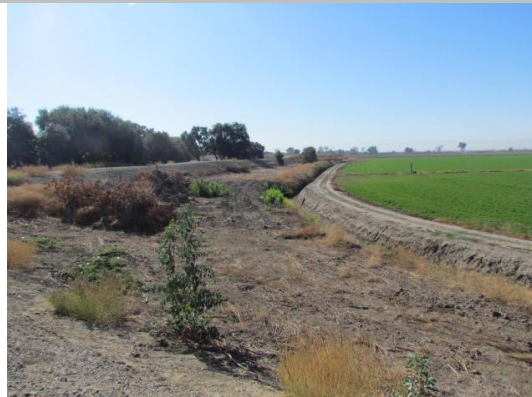
Photo 1 of 2 : FA\_2016\_RD0544\_108\_33\_20160929\_00023.jpg

Looking southwest at cleared landward slope and berm fall 2015.

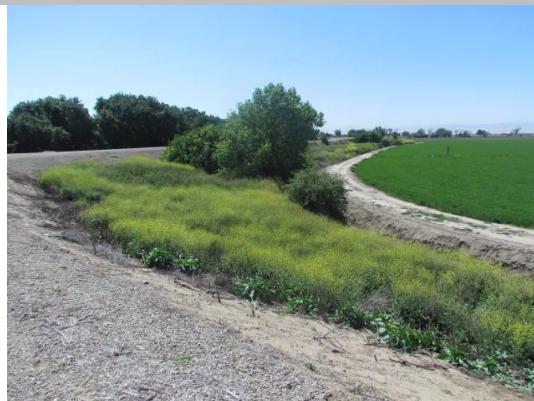
Photo 2 of 2 : FA\_2016\_RD0544\_108\_33\_20160929\_00024.jpg

Looking southwest at dense vegetation at landward slope and toe.(Spring 2015)

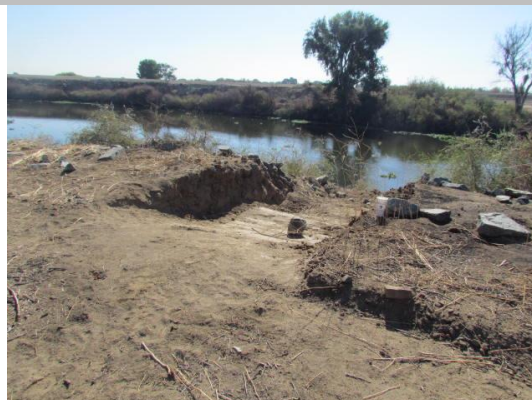
Photo 3 of 4 : FA\_2016\_RD0544\_108\_121\_20160929\_00078.jpg

Looking northeast at excavation on waterward berm

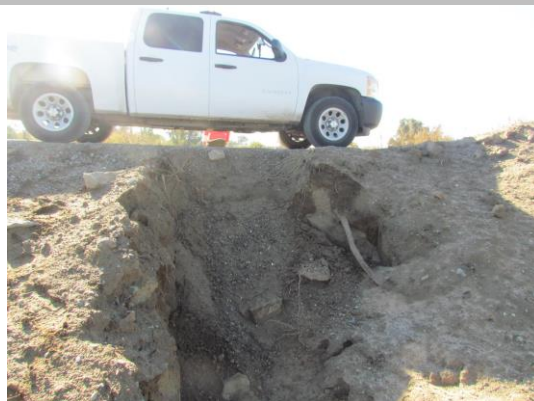
Photo 2 of 3 : FA\_2016\_RD0544\_108\_115\_20161107\_00146.jpg

Looking westly at large excavation on landward slope.

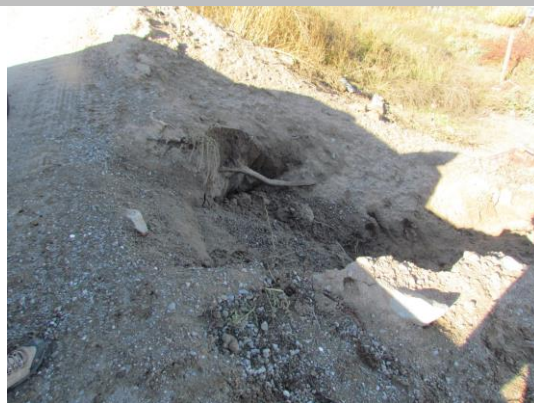
Photo 3 of 3 : FA\_2016\_RD0544\_108\_115\_20161107\_00148.jpg

Looking south at large excavation on landward slope.

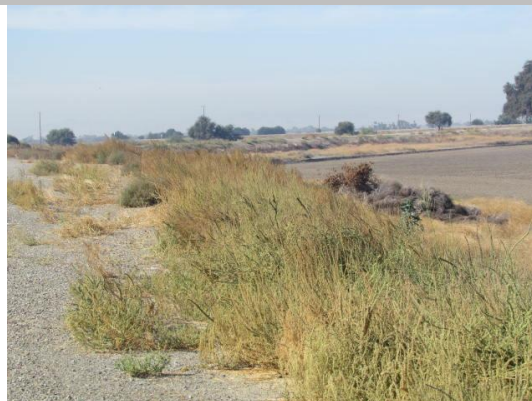
Photo 1 of 2 : FA\_2016\_RD0544\_109\_3\_20160929\_00002.jpg

Looking south at dense veg on landward slope and toe fall 2015.

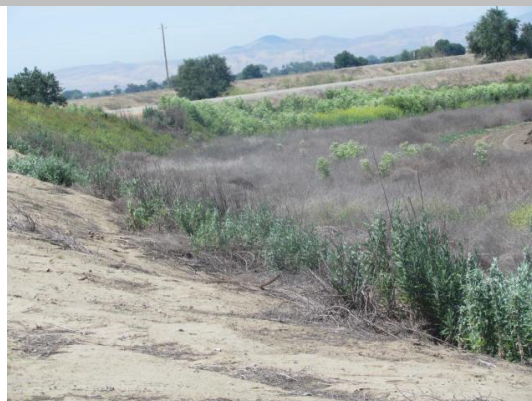
Photo 2 of 2 : FA\_2016\_RD0544\_109\_3\_20160929\_00003.jpg

Looking south at dense vegetation at landward toe spring 2014.

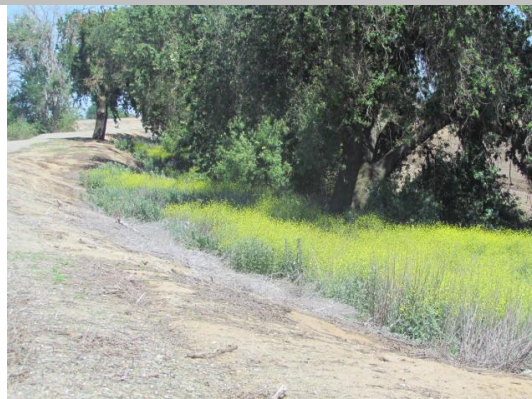
Photo 1 of 1 : FA\_2016\_RD0544\_109\_1\_20160929\_00001.jpg

Looking southwest at dense vegetation at landward toe.

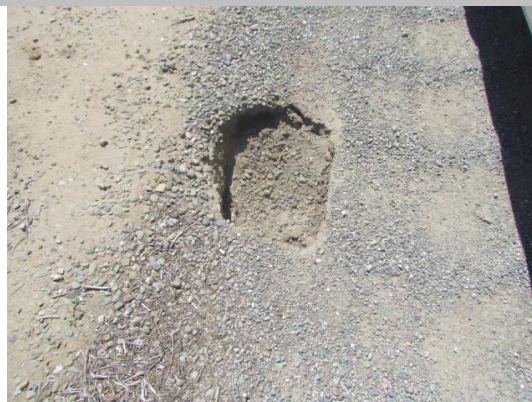
Photo 1 of 1 : FA\_2016\_RD0544\_109\_46\_20160929\_00041.jpg

Looking at depression on landward shoulder.

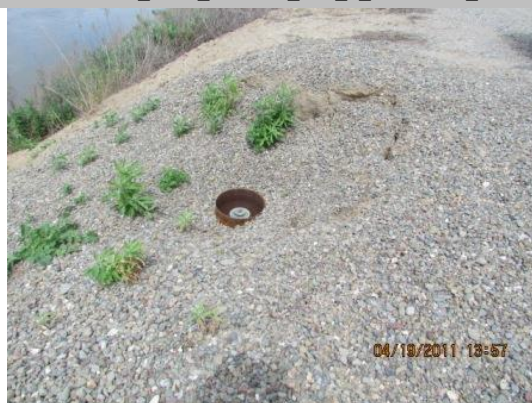
Photo 3 of 6 : FA\_2016\_RD0544\_109\_8\_20160929\_00009.jpg

Looking south at depression greater than 6" on waterside shoulder.

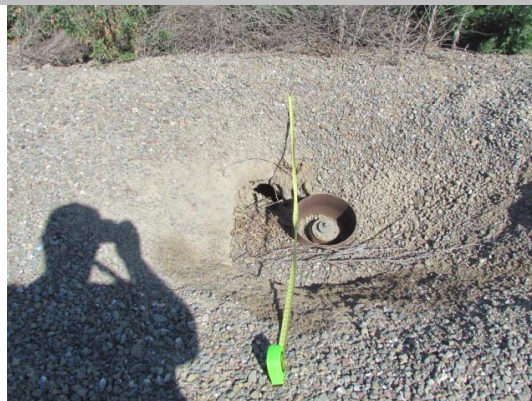
Photo 4 of 6 : FA\_2016\_RD0544\_109\_8\_20160929\_00010.jpg

Looking east at caving around siphon on waterside shoulder. (Spring 2012)

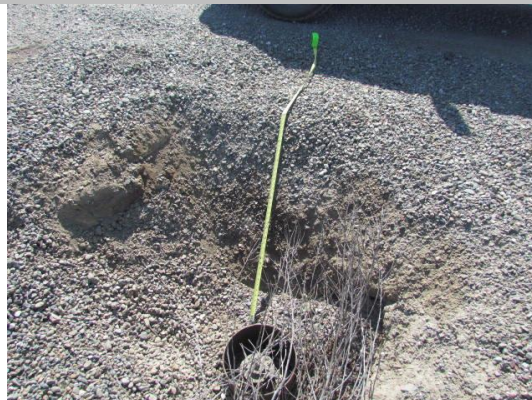
Photo 5 of 6 : FA\_2016\_RD0544\_109\_8\_20160929\_00012.jpg

Looking west at caving around siphon on waterside shoulder. (Spring 2012)

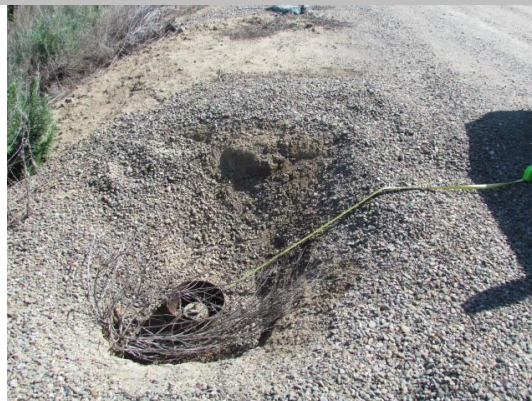
Photo 6 of 6 : FA\_2016\_RD0544\_109\_8\_20160929\_00013.jpg

Looking south at caving around siphon on waterside shoulder. (Spring 2012)

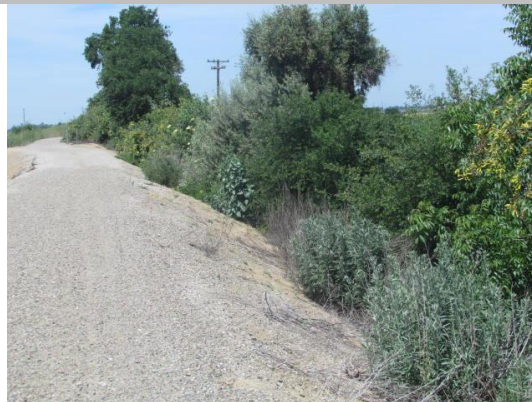
Photo 2 of 2 : FA\_2016\_RD0544\_109\_49\_20160929\_00042.jpg

Looking southwest at dense vegetation on landward slope and toe.

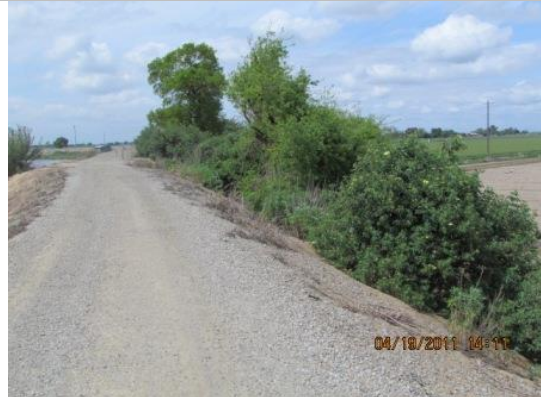
Photo 1 of 2 : FA\_2016\_RD0544\_109\_10\_20160929\_00018.jpg

Looking southwest at elderberries on landside slope.

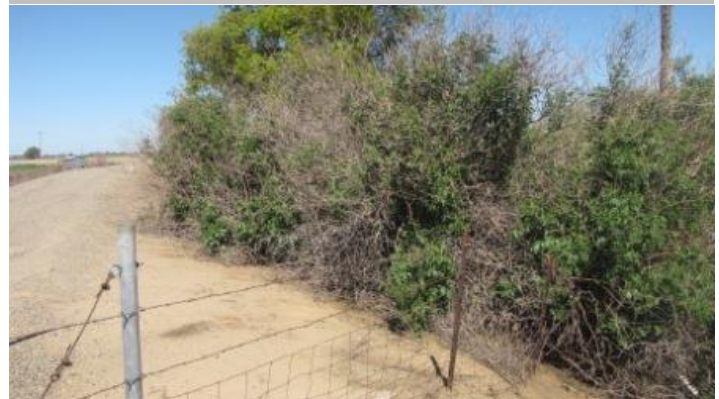
Photo 2 of 2 : FA\_2016\_RD0544\_109\_10\_20160929\_00019.jpg

Looking south at elderberries on landside slope and toe.

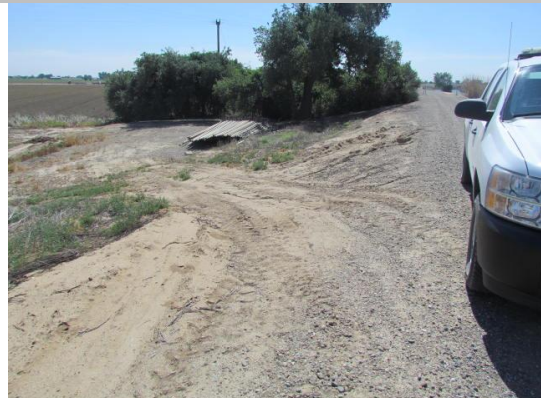
Photo 1 of 2 : FA\_2016\_RD0544\_109\_22\_20160929\_00032.jpg

Looking northwest at slope damage caused by vehicle traffic.

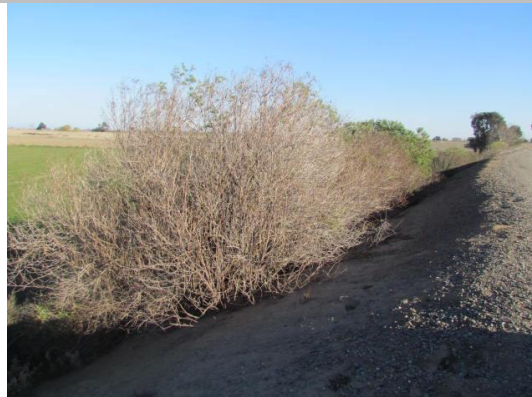
Photo 1 of 1 : FA\_2016\_RD0544\_109\_13\_20160929\_00022.jpg

Looking northwest at elderberries on landside slope and toe.

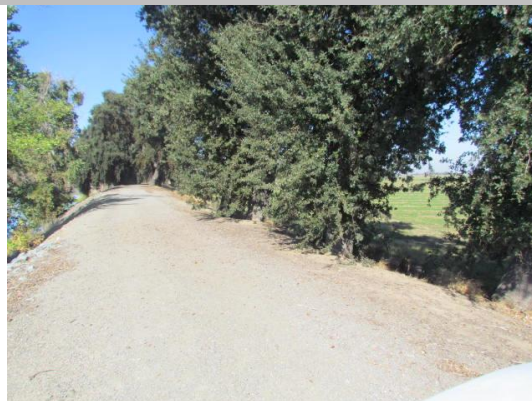
Photo 1 of 1 : FA\_2016\_RD0544\_109\_59\_20160929\_00051.jpg

Looking southwest at untrimmed trees on landward slope and toe fall 2015.

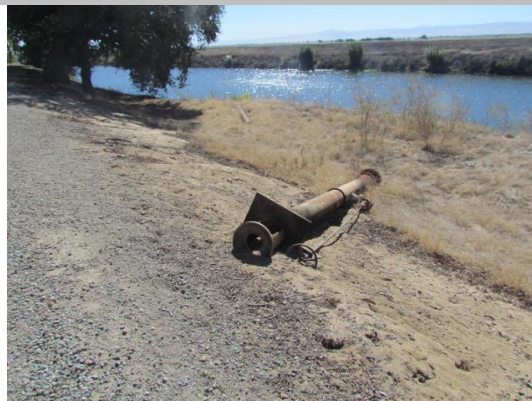
Photo 1 of 1 : FA\_2016\_RD0544\_109\_50\_20160929\_00044.jpg

Looking northwest at pipe on waterward slope.

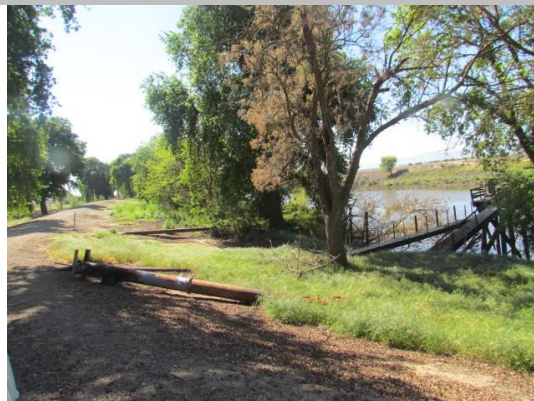
Photo 1 of 1 : FA\_2016\_RD0544\_109\_51\_20160929\_00045.jpg

Looking north at old pump shaft and pipe on waterward slope.

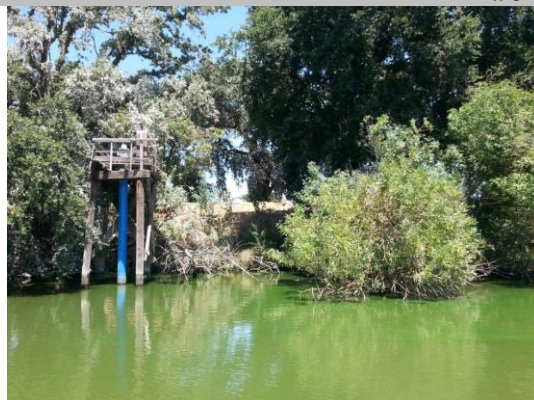
Photo 1 of 2 : SJR2016\_RD0544U02RM33.21\_1.jpg

Front view of the erosion site. View is partially blocked by the pump structure and vegetation at the site.

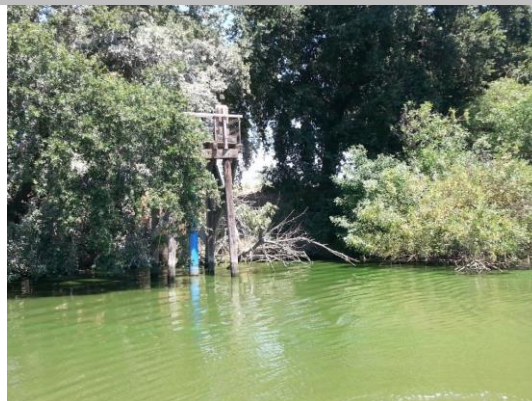
Photo 2 of 2 : SJR2016\_RD0544U02RM33.21\_3.jpg

Close view of the site.

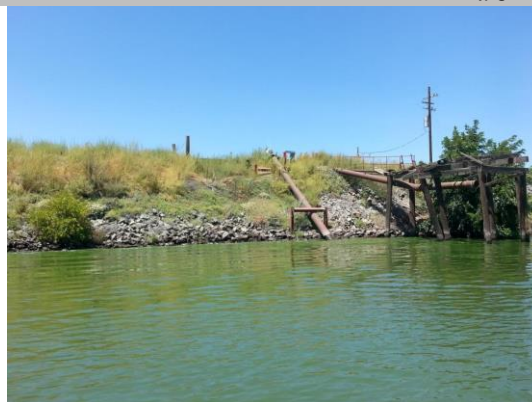
Photo 1 of 2 : SJR2016\_RD0544U02RM33\_1.jpg

Front view of the erosion site.

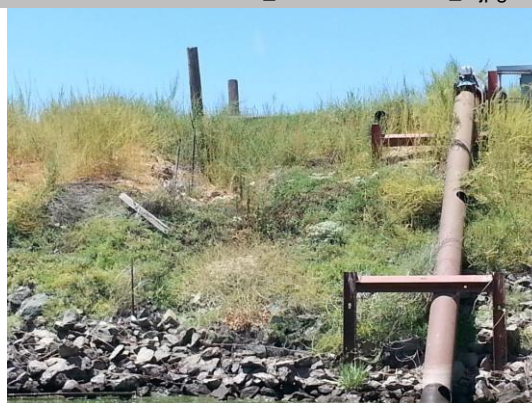
Photo 2 of 2 : SJR2016\_RD0544U02RM33\_3.jpg

Close view of the erosion. Vegetation around the site is visible.

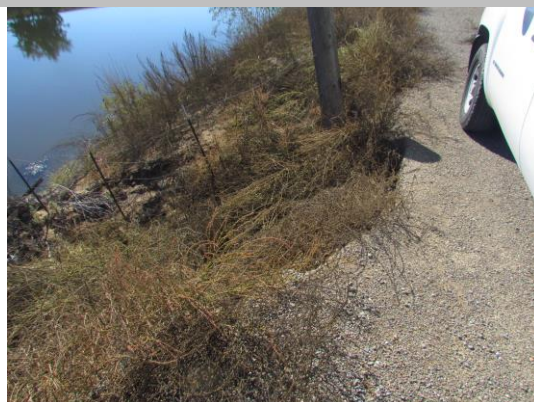
Photo 1 of 3 : FA\_2016\_RD0544\_109\_69\_20161107\_00093.jpg

Looking south at erosion on waterward shoulder and slope.

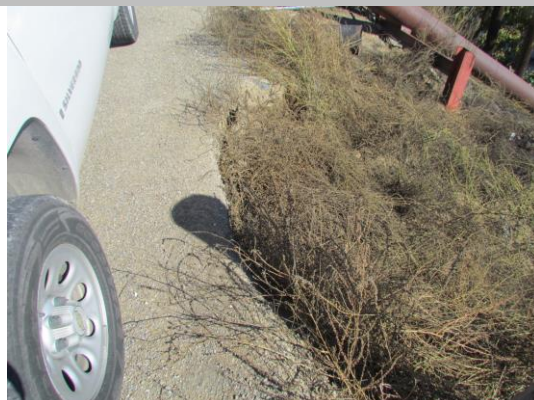
Photo 2 of 3 : FA\_2016\_RD0544\_109\_69\_20161107\_00092.jpg

Looking north at erosion on waterward shoulder and slope.

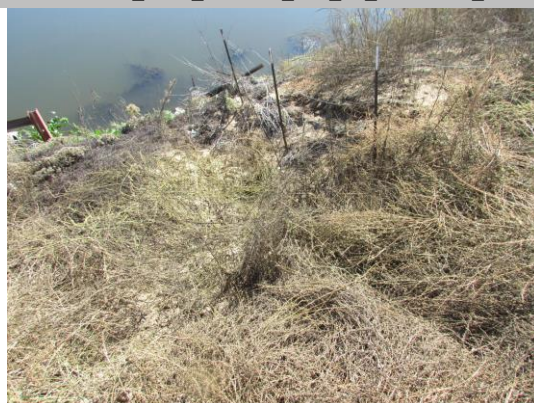
Photo 3 of 3 : FA\_2016\_RD0544\_109\_69\_20161107\_00094.jpg

Looking south at waterward erosion.

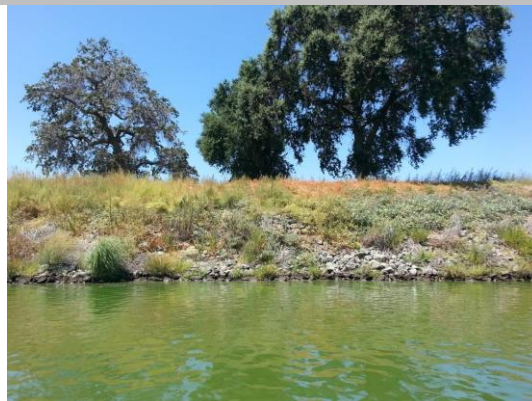
Photo 1 of 2 : SJR2016\_RD0544U02RM32.91\_1.jpg

Front view of the pocket erosion. Note the vegetation and riprap at the site.

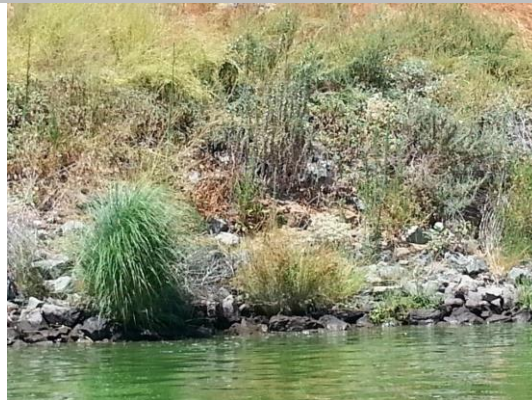
Photo 2 of 2 : SJR2016\_RD0544U02RM32.91\_3.jpg

Close view of the erosion.

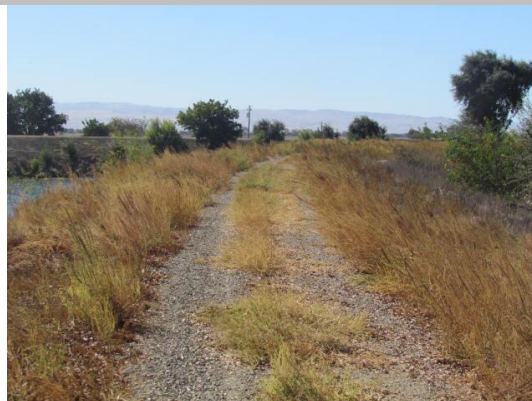
Photo 1 of 1 : FA\_2016\_RD0544\_109\_52\_20160929\_00046.jpg

Looking south at vegetation on levee crown.

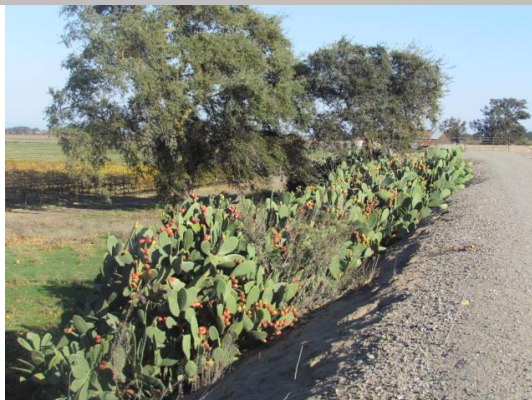
Photo 2 of 3 : FA\_2016\_RD0544\_109\_36\_20160929\_00036.jpg

Looking north at cactus on landside slope and toe spring 2015

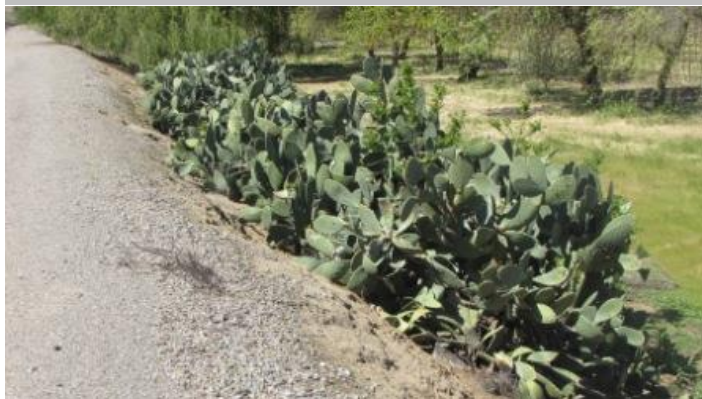
Photo 3 of 3 : FA\_2016\_RD0544\_109\_36\_20160929\_00037.jpg

Looking southwest at overgrown cactus on landside slope spring 2015.

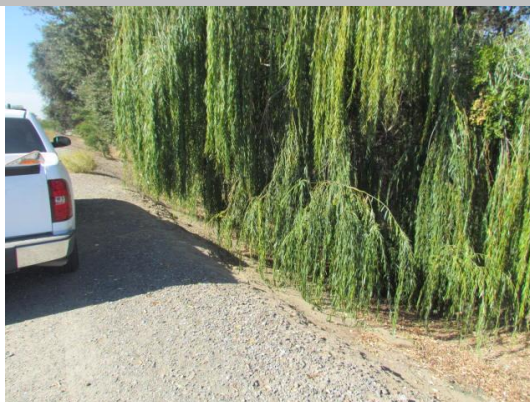
Photo 1 of 1 : FA\_2016\_RD0544\_109\_55\_20160929\_00048.jpg

Looking southwest at untrimmed trees on landward slope and toe fall 2015.

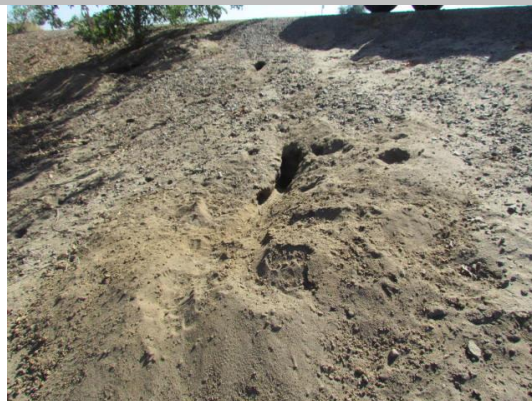
Photo 2 of 2 : FA\_2016\_RD0544\_109\_67\_20160929\_00056.jpg

Looking north at typical view of rodent holes on landward slope.
